New York State Department of Transportation

Yellow Flag NB22CTW002

BIN: 1065318

Location: Span 123 Girder G10 at Pier 122

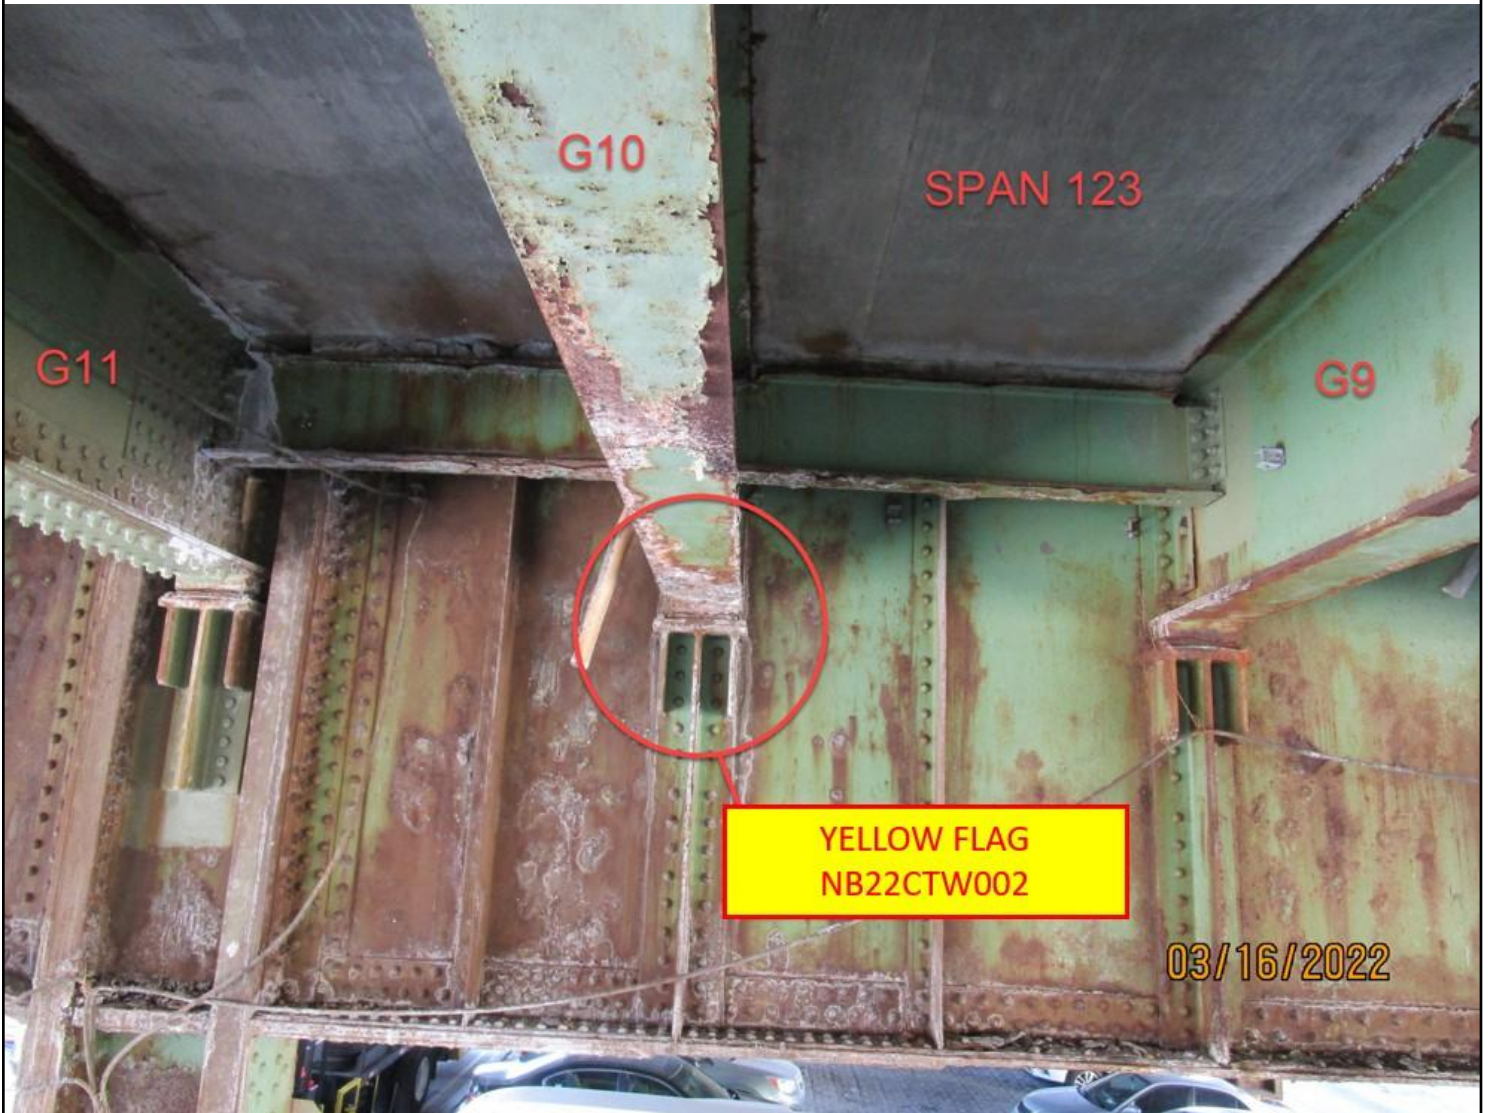
Photo Number: 1

Attachment Description: General view of the flagged condition at Girder G10 in Span 123 at Pier 122. Looking Begin.

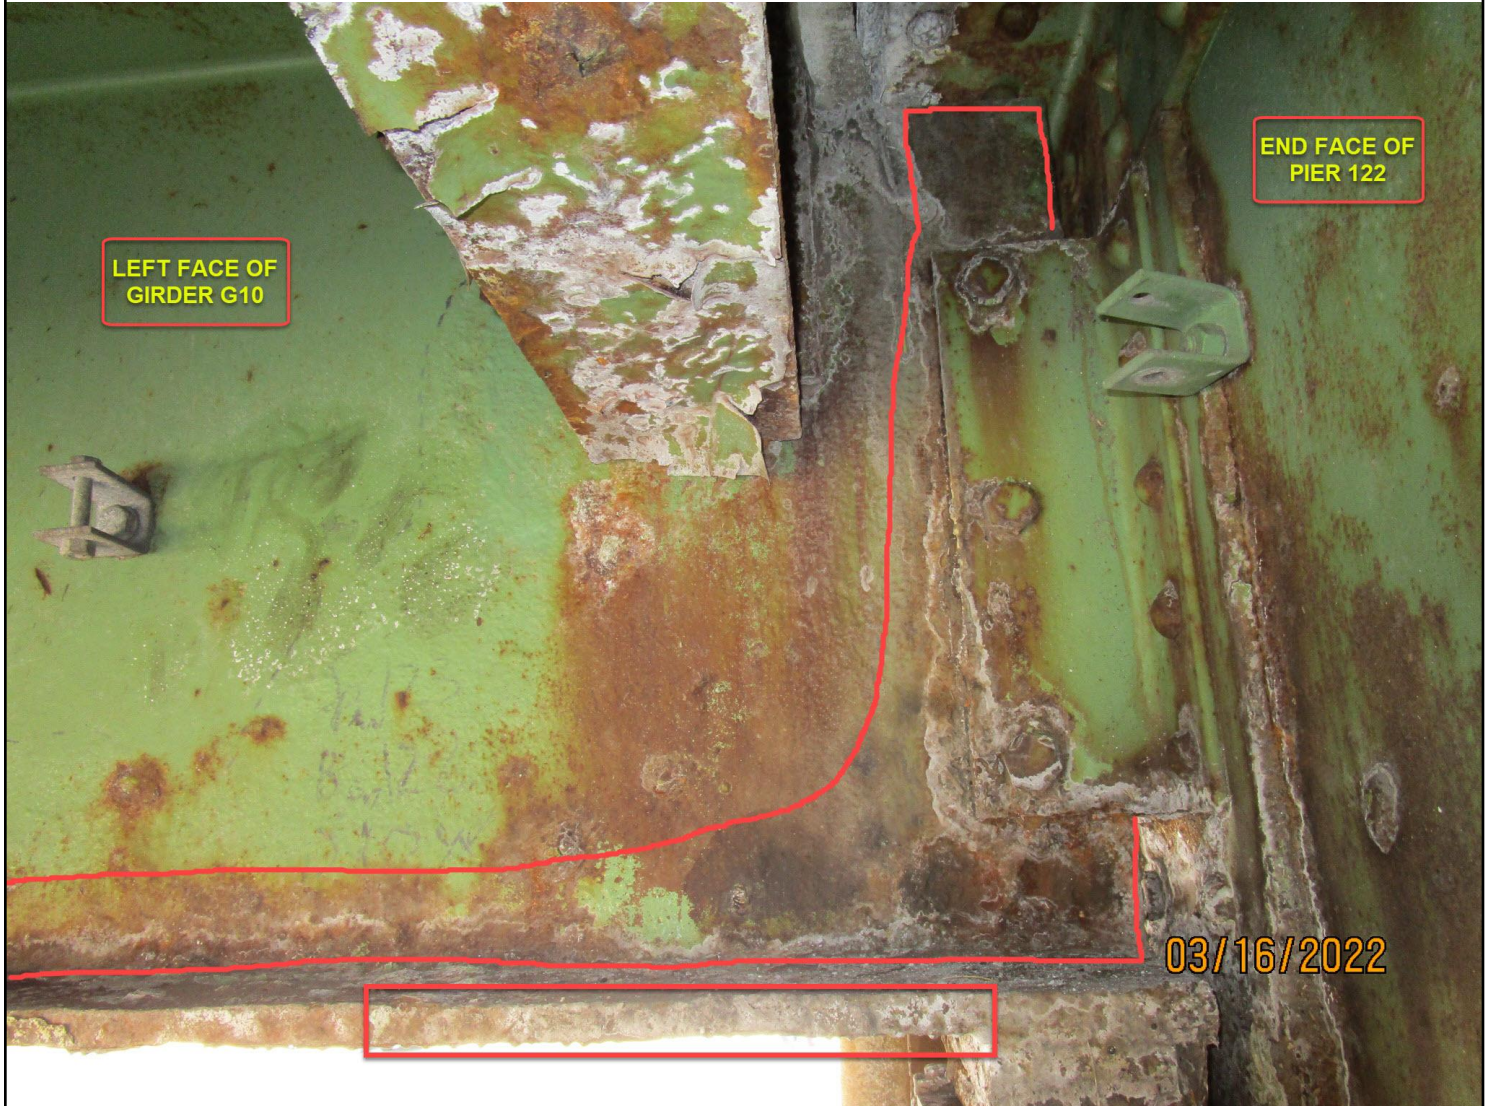
Photo Number: 2

Attachment Description: The left face of Girder G10 in Span 123 at Pier 122. The end of the girder exhibits severe section loss at the lower web above the bearing and web adjacent to the guide angle with section loss at the bottom flange. Looking Right.

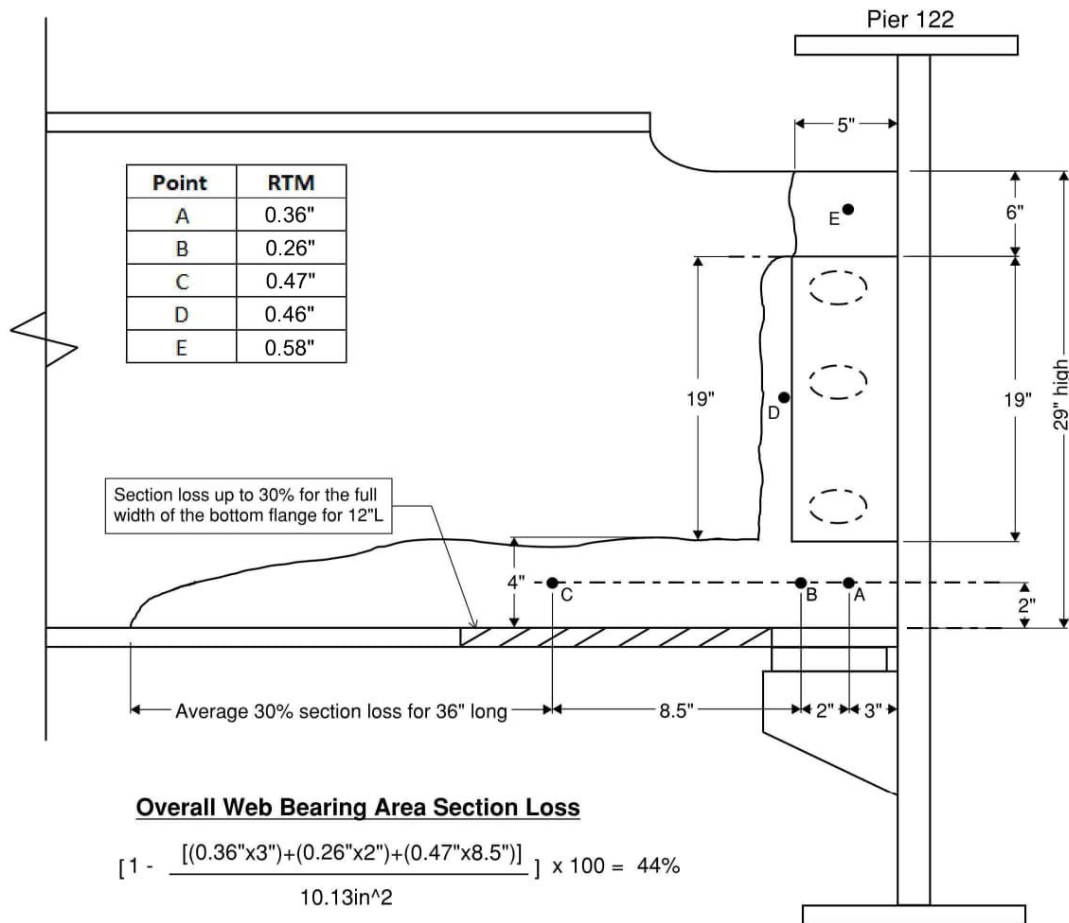
Left Face of Girder G10 Sketch in Span 123 at Pier 122

Description: The end of Girder G10 in Span 123 at Pier 122 exhibits severe corrosion resulting in an overall web bearing area section loss of approximately 44% (previously 52%) and an overall shear web area section loss of approximately 38% (previously 43%) with an overall localized section loss of approximately 57% (previously 70%) for 5"L x 4"H area directly above the bearing below the guide angle (Photos 2 and 3). Also, the lower web of the girder adjacent to the web bearing area exhibits average section loss up to 30% (no change) for 36"L x 3"H above the bottom flange. (Refer to sketch for more details).

**Overall Web Bearing Area Section Loss**

$$\left[1 - \frac{[(0.36" \times 3") + (0.26" \times 2") + (0.47" \times 8.5")]}{10.13 \text{ in}^2} \right] \times 100 = 44\%$$

Overall Shear Web Area Section Loss

$$\left[1 - \frac{[(0.31" \times 4") + (0.46" \times 19") + (0.58" \times 6")]}{21.75 \text{ in}^2} \right] \times 100 = 38\%$$

- As-built web thickness = 0.75"
- Length of bearing area = 18 x web thickness = 18 x 0.75" = 13.50"
- Overall bearing area = 13.50" x 0.75" = 10.13 in²
- As-built shearing web area = 29" x 0.75" = 21.75 in²
- Adjacent Girder G9 exhibits 35% localized section loss in the lower web above the bearing area with 25% section in the lower web above the bottom flange adjacent to bearing for 4'L x up to 3"H.
- Adjacent Girder G11 has previously installed steel reinforcement plate and angle at the end of the girder.

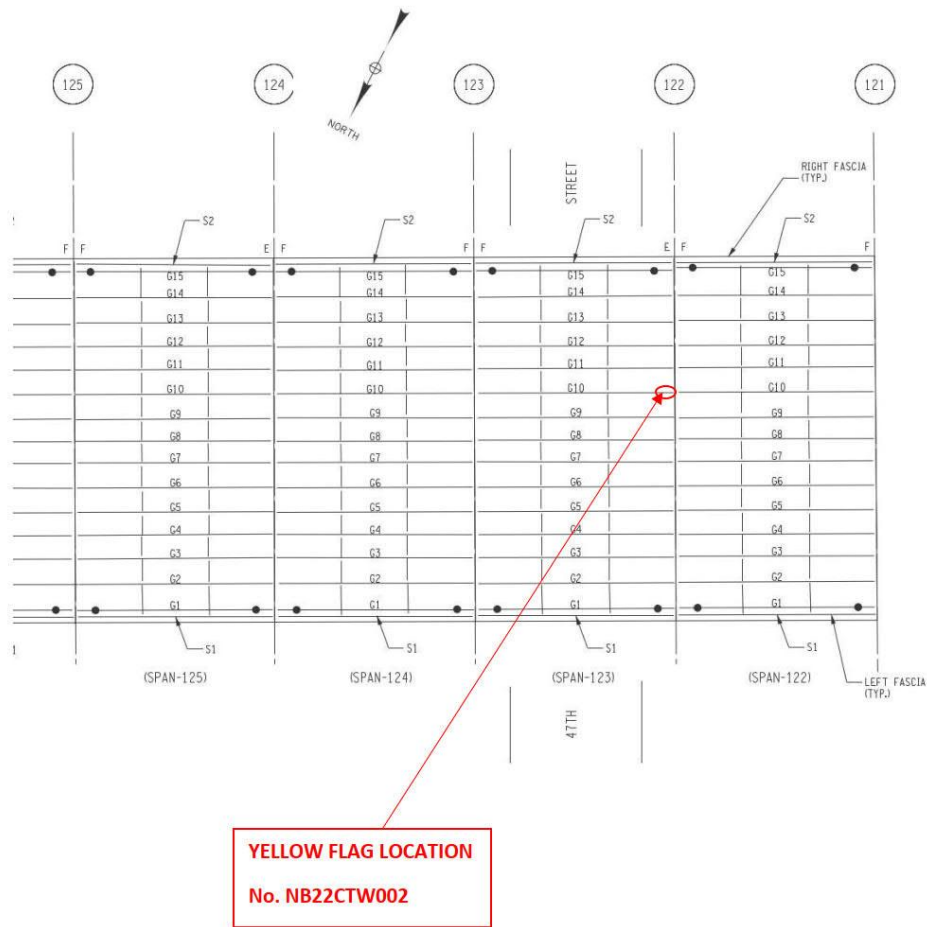
Photo Number: 5

Attachment Description: YF SN 123 G10 Framing Plan
